COMPACTION TEST REPORT

TEST RESULTS	MATERIAL DESCRIPTION
Maximum dry density = 132.2 pcf Optimum moisture = 6.5 %	LIGHT BROWN SAND WITH SILT AND GRAVEL
Project No. 376536 Client: RPM ENGINEERING, LLC Project: PINNACLE PAINTBALL PARK (RPM#87-100) ○ Source of Sample: BULK 01	Remarks: SAMPLE DESCRIPTION BASED ON VISUAL IDENTIFICATION
TRC Engineers, Inc. Mt. Laurel, NJ

EXAMINATION

Paint Ball Facility Constructed with 19 ISO Intermodal Shipping Containers

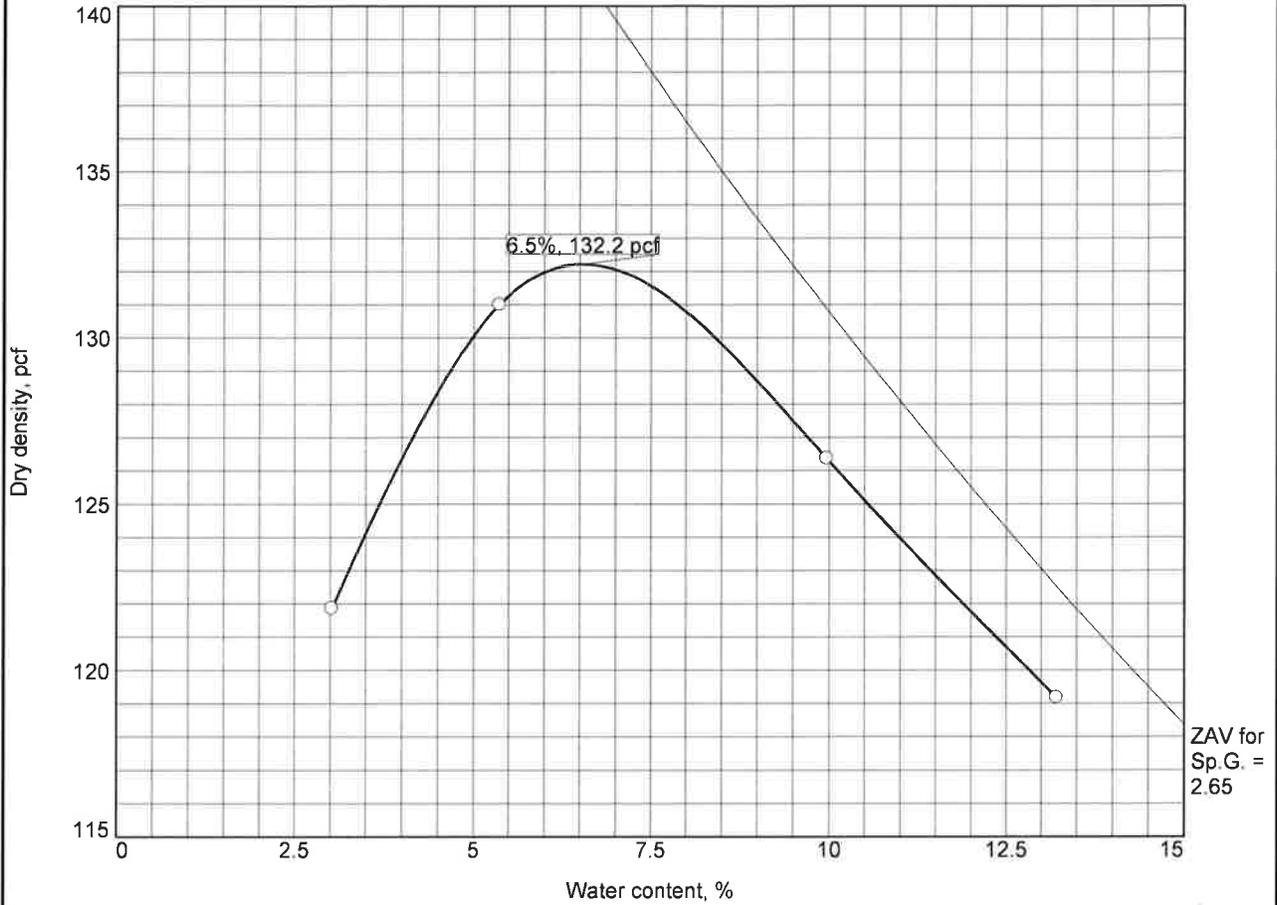
Figure 1

Test specification: ASTM D 1557-12 Method C Modified

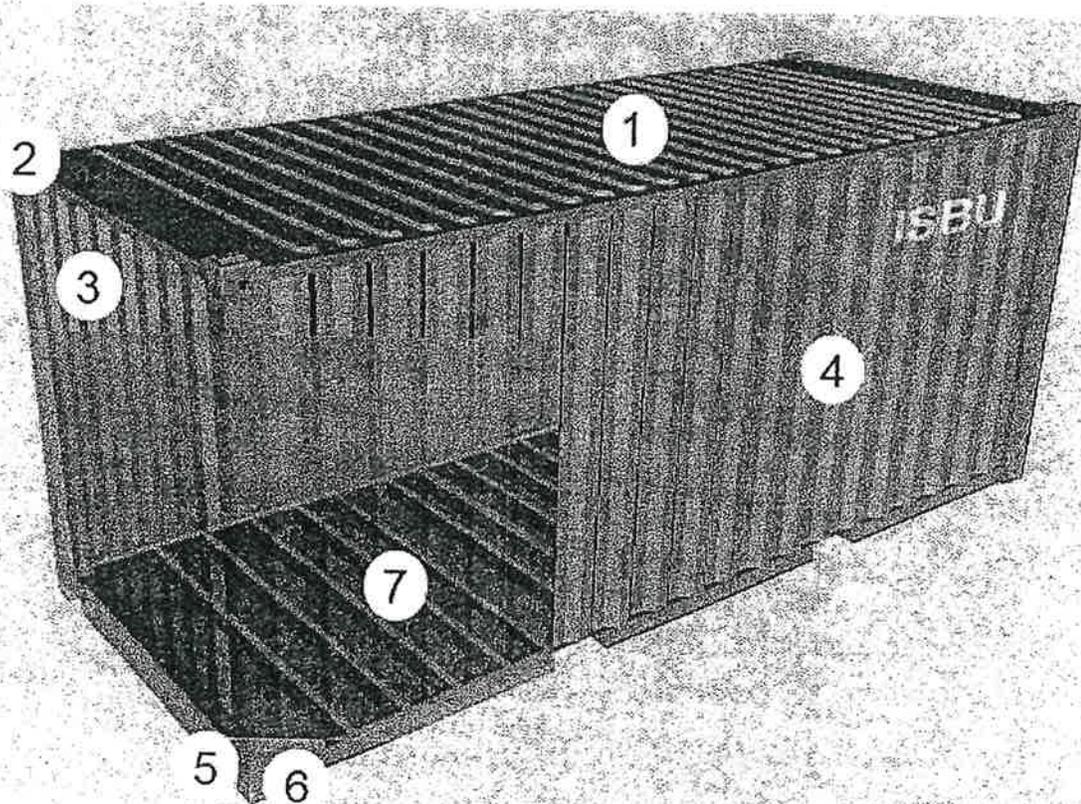
TYPE	ISBU (container) CERTIFICATION	UBC (Building Code) REQUIREMENTS	ISBU (times stronger) PERFORMANCE
1) Roof, uniform load, center	300 psf	20 psf	15.0 x
2) Roof, stacking, axial	53,000/per post	500/per post	106.0 x
3) End walls, lateral	366 psf	20 psf	18.3 x
4) Side walls, lateral	234 psf	20 psf	11.7 x
5) Racking/shear load "A"	16,800 lb.	680 lb.	24.7 x
6) Racking/shear load "B"	33,600 lb.	1,600 lb.	21.0 x
7) Flooring, uniform load	101 psf	40 psf	2.5 x

The container floors are rated at 2.5 times stronger than standard building rated floor strength. We have attached a copy of building code comparisons for all container strengths as compared to building code strengths. It should be noted that all the other container load values greatly exceed the building code values as shown on the attached building code comparisons.

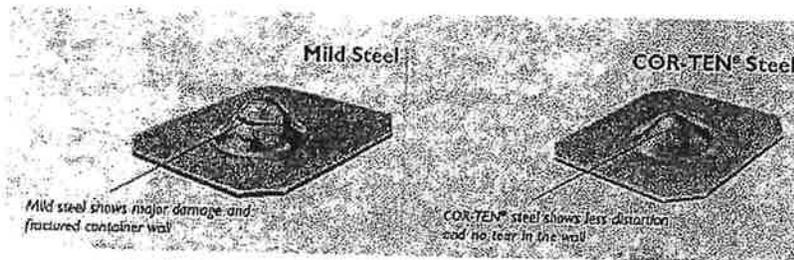
TEST: Corten steel used on shipping containers is virtually undamaged (Cronos)

Many independent studies have been done on shipping containers and the Corten steel used in the container construction. One such study was made by the Cronos Leasing company. The results of a study performed by a UK university concluded that Corten A steel was 75% stronger than mild steel. Their strength test was conducted using a hydraulic ram equivalent of over 20 tons per square inch.
